Navajo Abandoned Uranium Mine

Site Screen Report

Mine Name: Paul Huskie No. 21
Mine ID: 551

August 2011

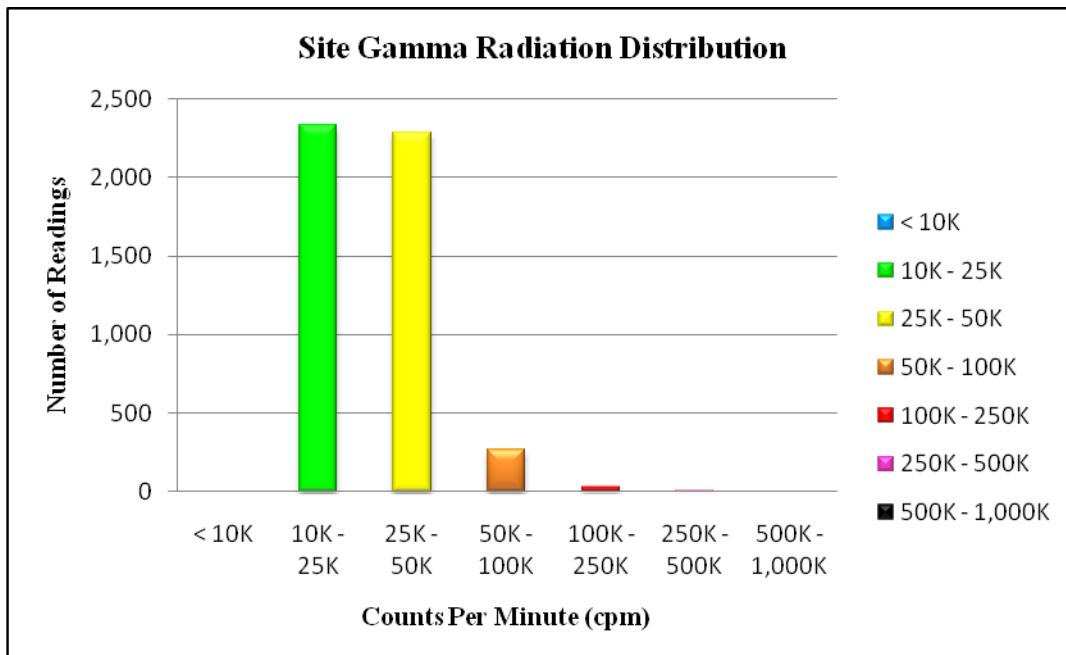
Highest gamma radiation measurement: 316,089 counts per minute (cpm)

Background Average: 18,938 cpm **Two Times Background:** 37,876 cpm

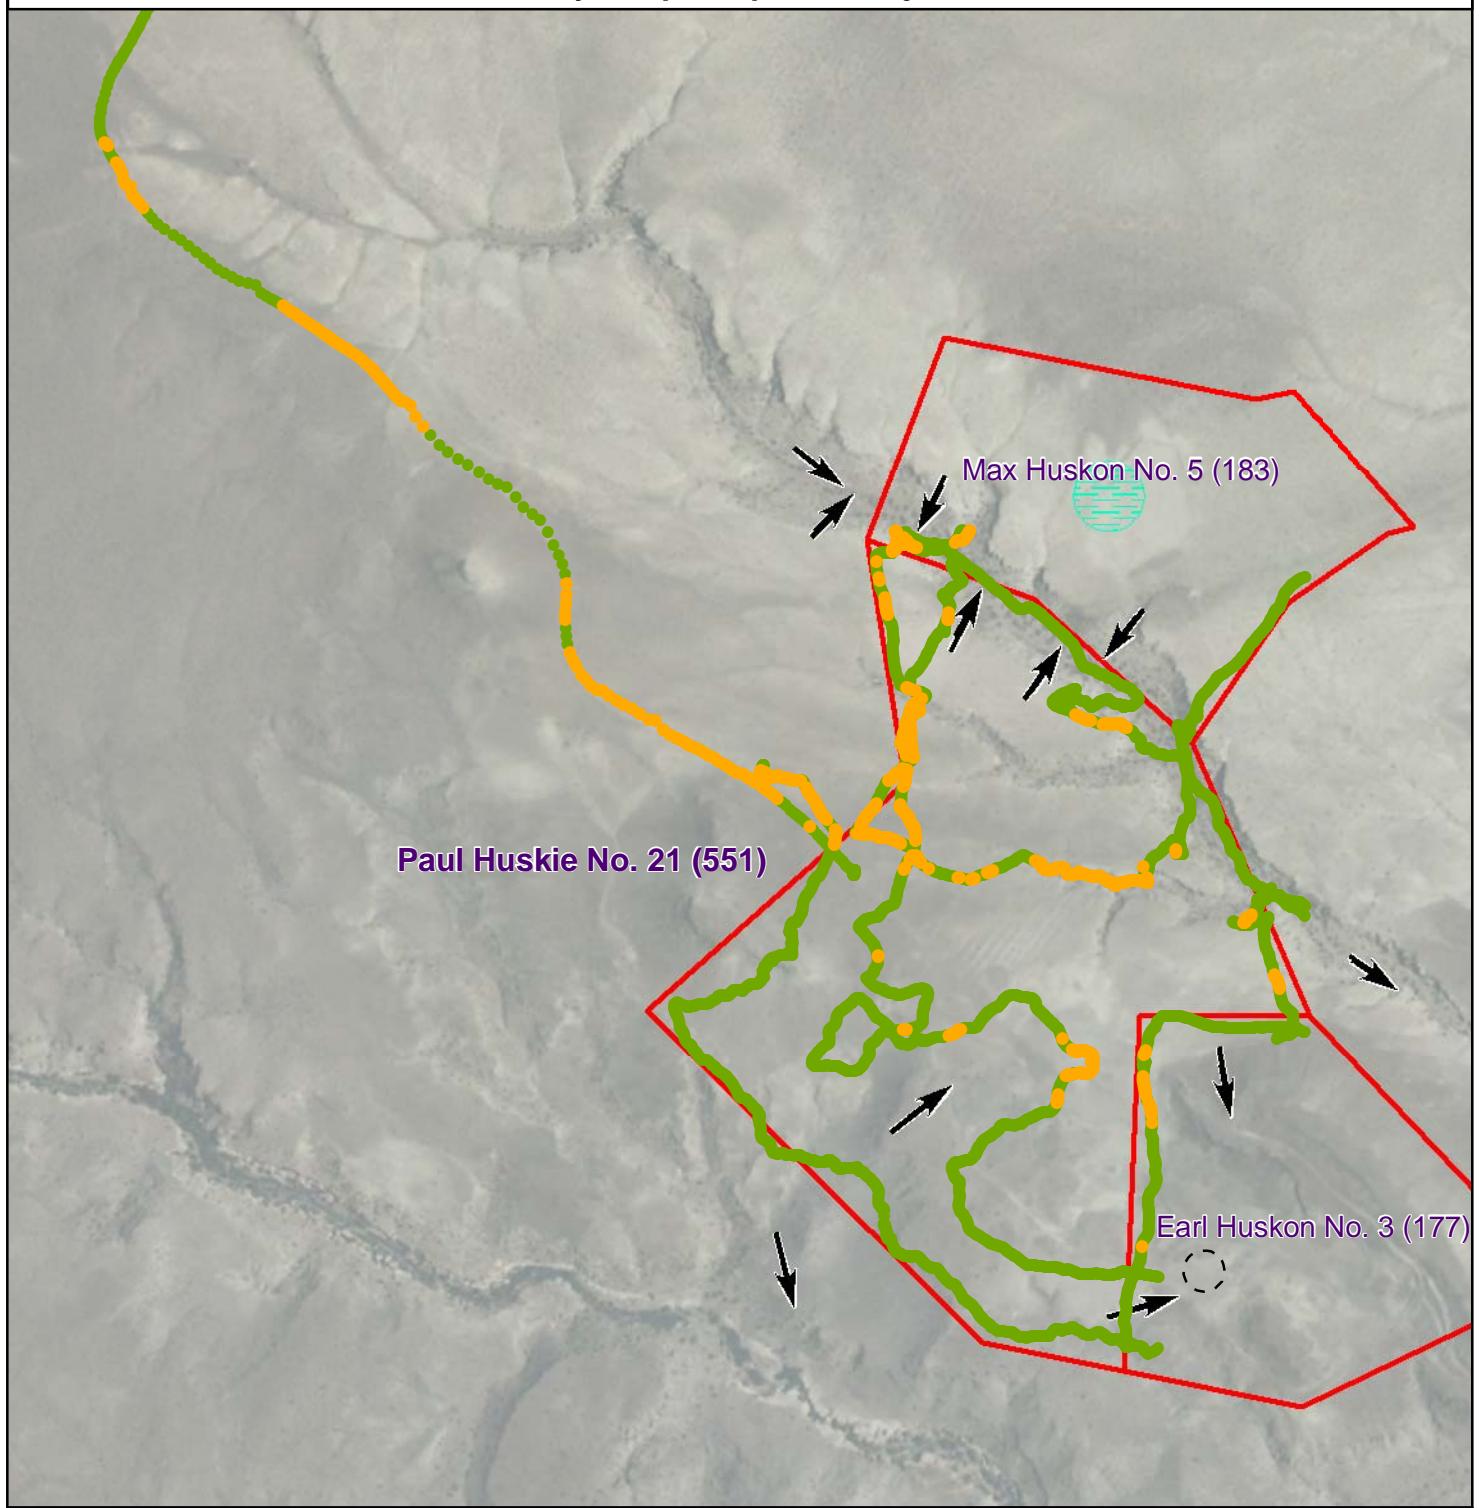
Figure 1 - Gamma Radiation Measurements, Above Two Times Background
Paul Huskie No. 21 (551)
Bodaway / Gap Chapter, Navajo Nation

A total of 4,924 gamma radiation measurements were collected from the mine site, ranging from 11,503 cpm to 316,089 cpm. Measurements collected along the path leading to the site from northwest were found at levels of approximately 175,000 cpm. The measurements are represented in Figures 1 and 2.
